Manhole Inspection Summary

Manhole # S11II_011MH

Insp Date: **10/9/07 3:01 PM**

Location Address: **1814 ROSEDALE ST**

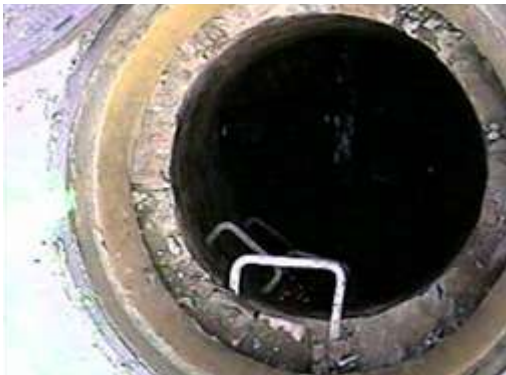
Top View

Offset: **4** (in.)

FRAME OFFSET

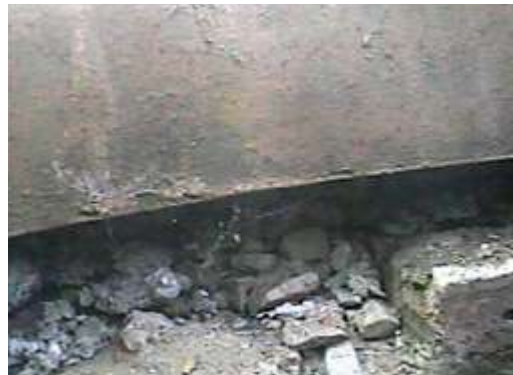
Defect 1

Condition: ☐ Sound ☒ **Cracked** ☐ Root Intrusion ☒ **Loose Brick** ☒ **Deteriorated**

LOOSE BRICKS, CRACKED, AND
DETERIORATED ADJ.

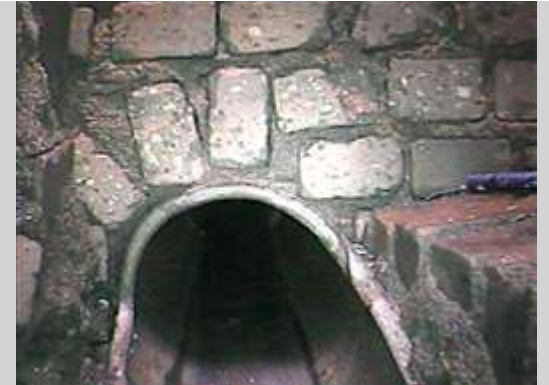
12 O'Clock Outflow

8 in. Circular Gravity Sewer
Pipe Out @ 12 O'Clock

Invert Depth: **8.68** (ft.) Flow Characteristics: **Slow**

Infiltration: **None** Pipe Seal Cond: **Sound**

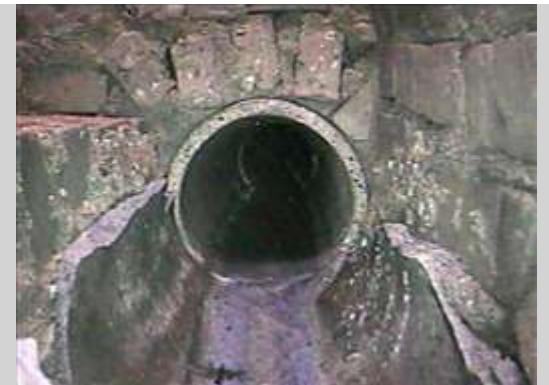
6 O'Clock Inflow

8 in. Circular Gravity Sewer
Pipe In @ 6 O'Clock

Invert Depth: **8.70** (ft.) Flow Characteristics: **Slow**

Infiltration: **None** Pipe Seal Cond: **Sound**

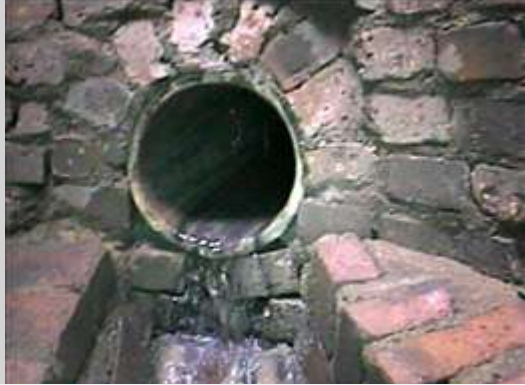
9 O'Clock Inflow

8 in. Circular Gravity Sewer
Pipe In @ 9 O'Clock

Invert Depth: **7.32** (ft.) Flow Characteristics: **Slow**

Infiltration: **None** Pipe Seal Cond: **Sound**
